BROOMHAUGH & RIDING PARISH COUNCIL

MARCH BURN BRIDGE

STRUCTURAL INSPECTION

BRIDGE INSPECTION, MILLFIELD ROAD, RIDING MILL

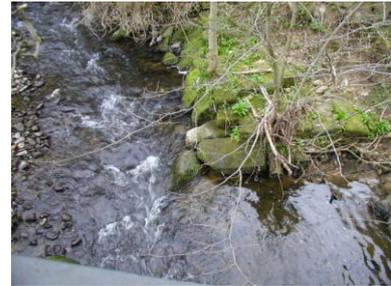
- 3.3 *Abutments* The abutments and wing walls are of mass concrete. The concrete is of poor quality, made from rounded river gravel and appears to have been poured into a shutter with no further compaction, as a result of which it has a honeycombed appearance. The thickness of the concrete abutment is not known and could not be readily measured. The wing walls vary in length due to the differing site conditions at each corner. To the north eastern corner some further mass concrete has been added in front of the wing wall to bring the wall back onto the alignment of the beck.

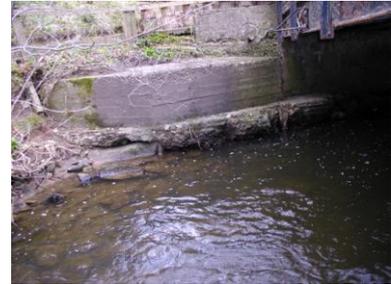
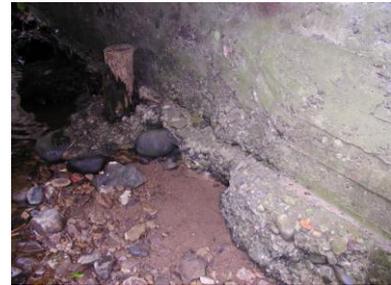
- 3.4 The abutments were formed of shuttered concrete and this appears to have been laid onto a foundation dug into the sand and gravel formation. Due to the passage of time, the river bed has lowered and the rough edges of the foundation are now exposed to both abutments. On the eastern side there is a small scour pocket under the abutment and a similar pocket under the north eastern wing wall. These are a maximum width of 0.5m or thereabouts so are beneath the outstand of the foundation but do not extend particularly under the mass of the abutment at this time.

- 4.2 The abutments are of plain mass concrete. The concrete is of poor quality and this has been commented upon in previous inspection reports. Nevertheless there appears to have been little or no deterioration of the concrete within the life of the bridge. The abutments continue to perform satisfactorily. There is evidence of scour beneath the eastern abutment and to a lesser extent beneath the north eastern wing wall. It is important that action is taken to fill in these holes without delay as they will become larger and could affect the overall stability of the bridge if not attended to. The flow of water through the bridge has, over time, lowered the bed of the beck. It is likely that scour pockets will become an increasing problem in the future as the water flows past soil beneath the footings rather than just between the abutments. The water appears now to be around 0.3m deeper under the bridge than it was in the early 1990's. There is a section of mass concrete in front of the wing wall to the north eastern corner. It may be that this was placed in order to address the scour noted in the 1990's reports, but this section of concrete is itself now subject to scour and should be addressed in the same way as the abutment.

- 5.1 The bridge requires some repairs to the scour beneath the abutment, to the paint coatings on the bridge beams, the road surfacing and to the parapet fixings in order to extend its life.

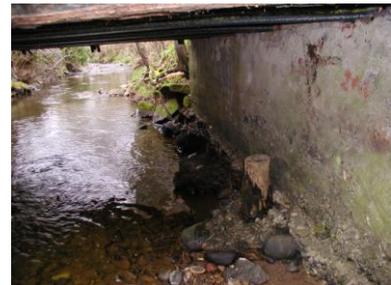
- 3.5 On the western side there are the remains of some 'telegraph pole' sized timber posts set into a concrete foundation and sitting just in front of the abutment. The history and purpose of these is not known, but they could be the remains of columns from an earlier timber bridge on this site.

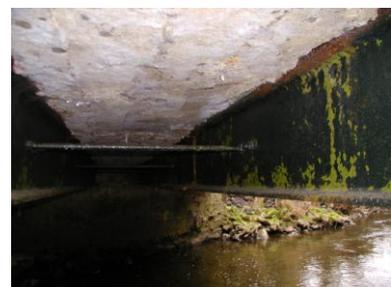
- 3.6 *Steelwork.* The bridge itself is supported on six steel beams, spanning on a skew, between the abutments. The beams were measured as a 16" x 6" x 50 lb/ft universal beam section, referencing to the 1932 Dorman Long handbook. There are bar ties running between the beams at mid-depth with either 3 or 4 sets of ties within each bay. The ties are staggered horizontally where they pass through and are bolted to, the beam webs. The beams are built in to the abutments at either end. The beams are all painted with a dark green finish over a lighter green undercoat.

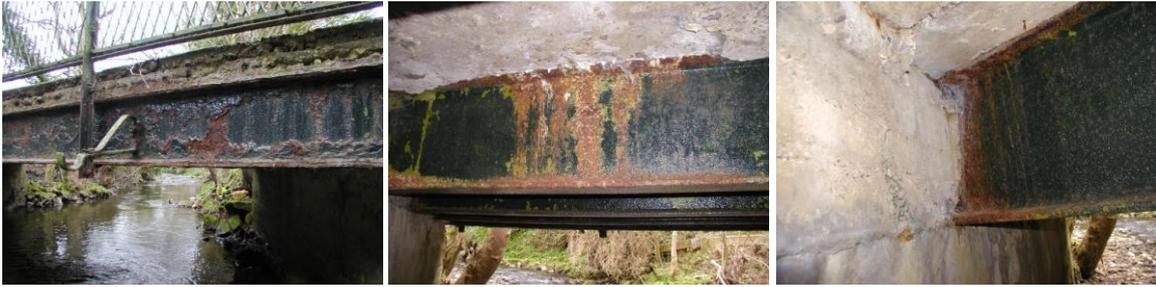
- 3.7 The two readily visible edge beams are in extremely poor condition. The paint finish has broken down and there are corrosion pits to both the web and flanges. The flange of the northern side beam at its western end has almost corroded away to nothing. There is fairly severe lamination to the beam steel in other locations. The northern edge beam is in marginally worse condition than the southern. The central four beams are, by contrast in quite good condition with little other than superficial corrosion apparent. The exception to this is where there has been some water seepage and where the beams are built in to the

concrete abutments at either end where the steel cannot be inspected, nor painted. In these positions some corrosion is apparent, although the extent cannot be determined.

- 4.3 The four central bridge beams are in quite good condition and, except at the bearings where they are built in to the concrete abutments; continue to function as intended when the

bridge was built. The paint coatings are reaching the end of their life and the beams would benefit from maintenance repainting with an appropriate industrial coating. The same is not the case for the two outer beams. These have suffered, principally from the effects of driving rain and water run off from the bridge deck. The corrosion to these is significant and has resulted in a loss of cross section to the steel beams. We assess this as a 50% loss of strength. These beams should be cleaned and repainted without delay otherwise plans will need to be put in place to remove these beams from the bridge. Even after painting the beams will still have a reduced residual strength and a reduced life expectancy compared to the central beams.

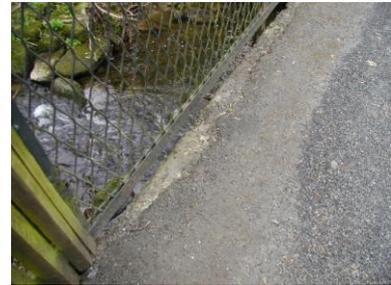
3.8 *Deck.* Sitting on the top flange of the beams is the bridge deck. This is of shuttered concrete and appears to have been made using the same river gravel as the abutments, with a similar limited degree of compaction. The deck is approximately 200mm thick. We could not determine from a visible inspection whether the deck is reinforced or not. There is no spalling or other deterioration to suggest that any embedded metal is corroding within the concrete. There is evidence of some leaching of water through the deck in a couple of locations but this appears to be relatively minor.

3.9 *Roadway.* The road surface is of a macadam material. This appears to have been overlaid with a surface dressing of fine gravel within a bitumen emulsion. This coating is breaking down and much of the gravel is sitting loose on the surface of the roadway. From what could be seen of the macadam beneath the surface dressing this may not be in good condition.

- 4.4 The concrete bridge deck remains in a serviceable condition. We suspect that the deck is un-reinforced and may in practice struggle to transfer high wheel loads onto the adjacent beams. There is evidence of some leaching of water through the deck. What effect this may be having on the top flange of the beams is not known. Maintaining the macadam wearing course on the top of the bridge in good condition will help to ensure some waterproofing to the deck.

- 4.5 The surface dressing applied to the bridge at the time the bollards were added is breaking up in cold weather. The macadam layer beneath is also not in good condition. It would be prudent to lift and replace the macadam layers in order to maintain the integrity of the bridge deck waterproofing and to maintain the quality of the surface finish texture.

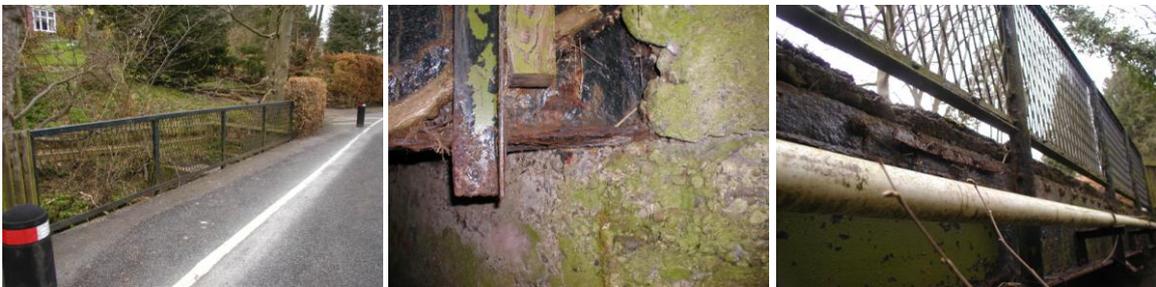
3.10 *Parapet walls.* The parapet walls are formed from steel angle posts, bolted to the top and bottom flanges of the edge beams. There are five posts to each parapet. Spanning between the posts are angle rails, one at the top and one just above the road surface level. Between the rails are sheets of expanded metal mesh clamped and bolted between the angles and flat plates. To the edge of the road deck there appears to be a continuous angle fixed to the top flange of the beam. This has almost wholly corroded away.

- 4.6 The parapets to either side are in quite a poor condition, being attached to the corroding edge beams and subject to the same weathering, water run-off and road spray. The connections from the parapet posts to the beam are particularly poor, especially the top flange fixing. These should be thoroughly cleaned off and repainted and may require further remedial works to make them secure. The design of the parapets would not be considered as suitable to today's standards as they will be unable to provide much, if any resistance to a stray vehicle driving off the side of the deck. The fences on the approach to the bridge are simple timber boundary fences and, in a similar way, will offer little resistance to prevent vehicles accidentally falling into the beck.

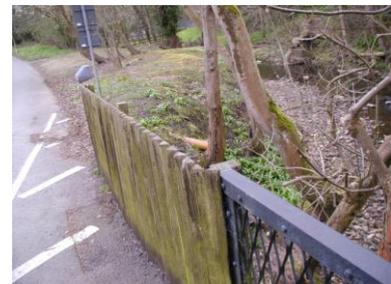
3.11 *Drainage.* There is no drainage provided on the bridge deck itself. There are two road gullies at the kerb on the southern side of Millfield Road 4.9m and 13.4m uphill of the bridge. One of these appears to discharge onto the river bank just upstream of the bridge and the other onto the riverbank just below the bridge. It appears as if the water runs off the side of the bridge deck onto the edge beams below.

- 4.7 The absence of any drainage to the bridge will be a contributory factor to the poor condition of the edge beams. Providing better drainage will be difficult in practice on an existing structure.

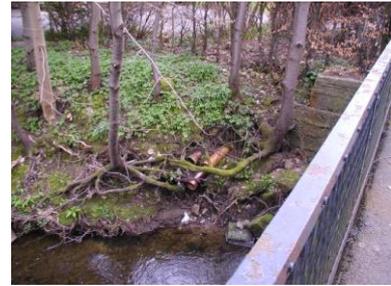
- 3.12 *Services.* There are three piped services which cross the bridge. There is a pipe attached to the southern edge beam which appears to be either gas or water. There are two smaller pipes between beams 2 and 3, and between beams 3 and 4. These may be electricity, street lighting or water. There is a capped off service that was formerly attached to the northern edge beam.

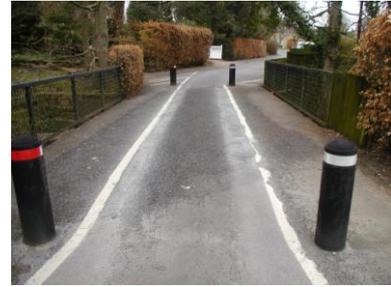
- 3.13 *Road Restrictions.* Works have been carried out fairly recently, we understand by Northumberland County Council, to restrict the road. There are plates showing a 3 Tonne weight restriction. This restriction is reinforced by four bollards, two to each end of the bridge that limit the width of vehicle able to pass across the bridge. The bollards have a clear space between them of 11.75m and restrict the road width to 2.16m. This width is visibly reinforced by a solid white line between the bollards. The bollards are constructed of a relatively soft recycled rubber material. This appears to be becoming cracked at the bottom on a couple of the bollards. Prior to the most recent restriction the bridge had a 7.5 tonne weight limit (as can be seen on 'Google Earth Street View' images).

- 4.8 The bollards and weight restriction imposed on the bridge by the County Council have fairly effectively restricted the class and size of vehicle able to use the bridge. Previously, although there was a 7.5 tonne weight limit on the bridge, there was nothing to prevent much larger vehicles using the bridge and the road. The central four beams have significantly greater strength than the two edge beams. The restriction is in practice fairly effective in keeping vehicles on the bridge largely to the central section where the beams are stronger. Whilst larger vehicles would not unknowingly be able to get onto the bridge there is nothing to prevent cars from driving right on the edge of the bridge deck in the space between the pairs of bollards, resulting in loading on the weak edge beams.
