Report on Options to modify the Mill Weir on the March Burn, Riding Mill – Initial Draft for Comment – 7th June 2011

1. Background and Executive Summary

1.1 This report was commissioned by Riding Mill Parish Council to explore the options of lowering a section of the crest of the weir, and also the option of removing the entire weir.

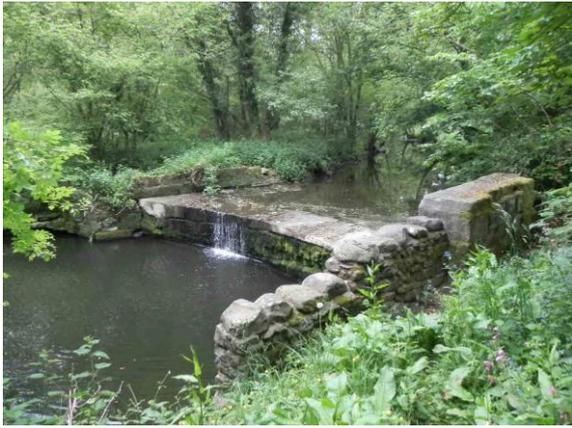
Figure 1 – Riding Mill Weir from the left bank

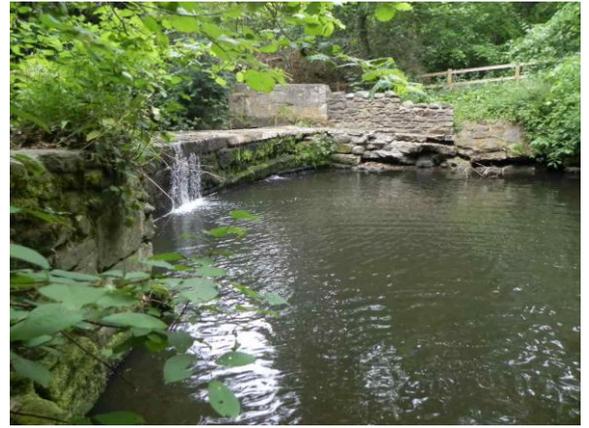
3.2 The condition of the masonry at this bank is fairly poor, with evidence of sections being washed away and some undercutting of the structure. Although the side walls appear to be currently stable, further high flows will inevitably lead to further deterioration and failure could be expected in the next 5-10 years without further maintenance work.

3.3 A particular concern is an area near the water surface where sections of masonry have been lost, leading to under-cutting of the structure and further damage.

Figure 2 – The deep weir pool and area of erosion at the left bank.

6.9 It would also be advisable to repair the wall and masonry at the left bank where this has become undercut. This would require masonry to be mortared into place near water level, and care would be required to avoid pollution. Although it would be best to lower the water level to do this work, the costs of this would be high, and therefore mortaring work could be limited to sections above water level. These repairs could extend the life of the side wall by a further 5-10 years, but some further work may be needed in the future as it deteriorates further.

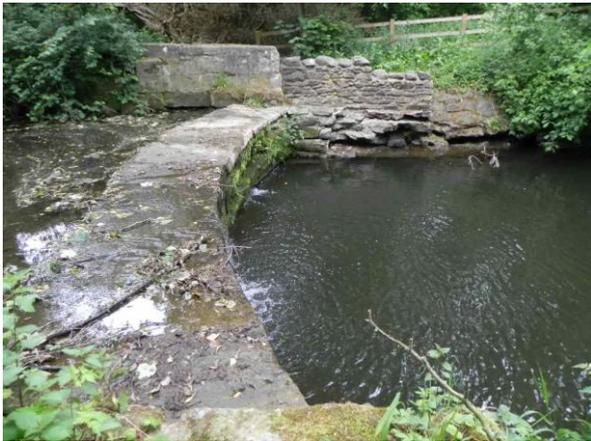
2.3 The main weir structure is in good condition considering its age. At some stage in the past, a concrete 'cap' has been poured to level the surface of the structure. This varies in thickness from 75mm at the left bank to a maximum of 400mm near the right bank. This concrete cap has had grooves formed into the surface to make it blend in with the stonework.

Figure 3 – the concrete cap at the weir crest.

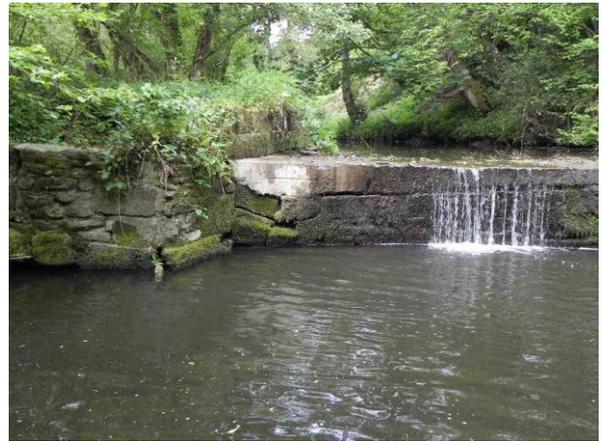
4.1 A 'corner' of masonry extends downstream into the weir pool at this bank. This corner is heavily undercut below the water surface, with a void extending under the masonry by up to 1m. ***This section could fail without warning if people were standing on it, resulting in people falling into the deep water below.***

4.3 Without further work, this side corner could be expected to fail in the next few years, probably during high flow conditions.

Figure 4 – the 'corner' to the left of the picture that is severely undercut below water level. The proposed notch would be roughly 2/3 of the weir height.

6.6 As part of the works, it would be advisable to also take down the corner of undercut masonry on the right bank before it collapses. As this is currently unstable, care would be needed to do this safely. The material could be left in the weir pool, although some of it could usefully be placed at the right bank to minimise further erosion. Silt management measures, such as straw bales would be required as part of this operation.

14.10 *The undercut corner on the right bank is of concern regarding public safety, and it may be appropriate to erect a fence and warning sign until this work can be carried out.*

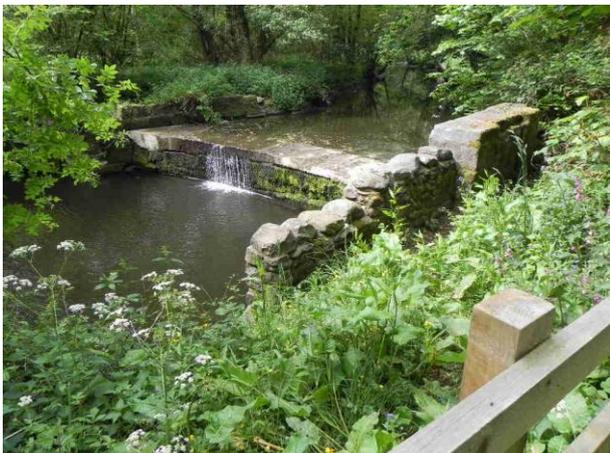
12.2 The provision a timber fence set back from the left bank was a wise measure, and significantly reduces the risks to the public.

Figure 5 – safety fence at the left bank (to be replicated at the right bank until urgent works can be completed)

12.3 Because there is a footbridge immediately downstream, and evidence of children playing at the site (there is a rope swing nearby), a similar fence should be erected at the right bank as a matter of urgency. As it is not obvious that the corner of masonry is severely undercut and unstable, a warning sign may also be considered appropriate until works can be carried out to make this safe. This could read 'Warning – this stonework and wall are unstable and may collapse. Very deep water' The fence should also be erected alongside the sign, as children may simply ignore signs.

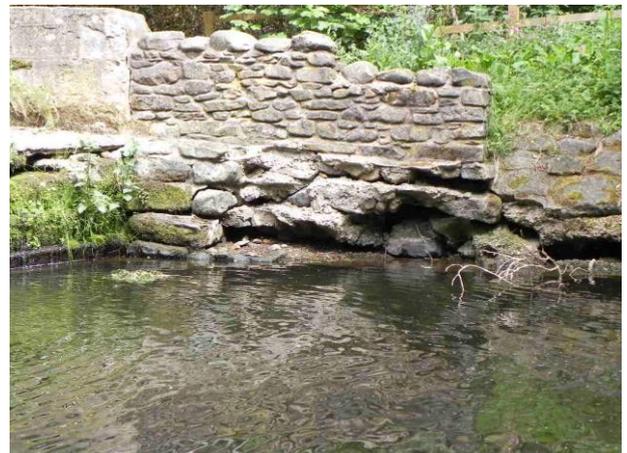
10.3 At the left bank, there is a section of masonry wall that appears to be relatively new (the stone is not flat faced, as with the original masonry). This work may have been a previous attempt to improve safety at the site, before the introduction of the timber fence. Unfortunately this stonework is becoming under-cut as sections of masonry have been washed out in flood conditions. Although this area of erosion could be repaired and re-pointed, it may be more prudent to simply take down this side wall, as well as making good the erosion area near water level. This would avoid the risk of the wall becoming further undermined in the future, and it possibly collapsing with people leaning against it to watch salmon jumping.

Figure 6 – section of new masonry at the left bank and area of erosion and undercutting.

- Form a sound, pointed surface to the notch, ensuring that the mortar does not come into contact with water. This may require a small pump.
- Take down the section of new masonry wall at the left bank and point and repair the section that is undercut (above water level).
