BROOMHAUGH & RIDING PARISH COUNCIL

MARCH BURN BRIDGE

STRUCTURAL INSPECTION

BRIDGE INSPECTION, MILLFIELD ROAD, RIDING MILL

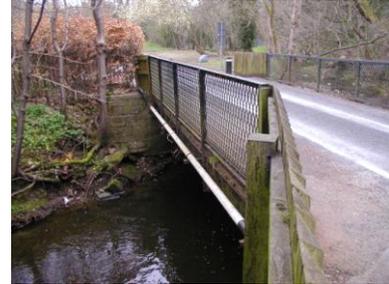
2.4 The bridge abutments are of concrete. The bridge structure is of steel beams with a concrete deck and expanded metal parapets. The road surfacing above is a thin layer of macadam on top of the concrete deck.

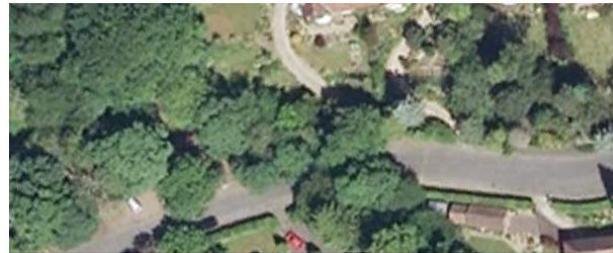
2.5 The bridge has been built with a skew of around 30°. The road also snakes over the bridge with the part of the road towards the A695 turning east and then turning north east and the other end reasonably straight to the south west. The bridge itself is level; the road towards the A695 is fairly level and the other end of the road rises away from the bridge. The sides of the beck are tree lined.

2.6 Overall the bridge feels in a solid condition with no movement or excessive vibration evident from either above or below whilst vehicles pass across it.
